PROPERTY INSPECTION REPORT

Concerning: 22 Park Blvd., Houston, TX, 77304
(Address or Other Identification of Inspected Property)

By: Dan smithTREC # 20iii716 10/31/2013
(Name and License Number of Inspector) (Date)

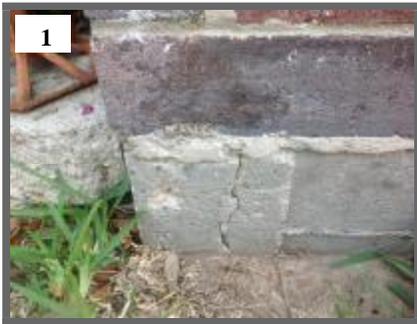
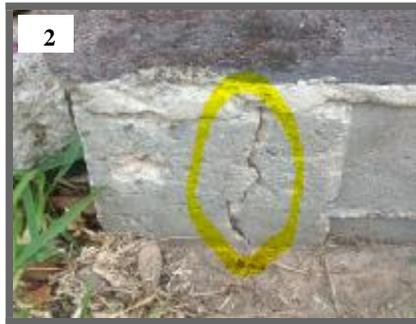
Corner pop
Crack

D - There are corner pops noted on the foundation. Corner pops are common on slab foundations and are not considered to be a major concern.
C - At this time the foundation appears to be providing adequate support for this dwelling based on a limited visual observation. I did not observe any evidence that would indicate the presence of significant deflections in the foundation. There were no notable functional problems resulting from foundation movement ..

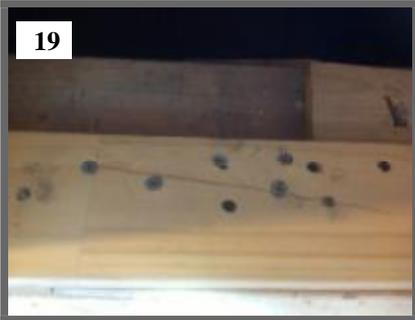
D - The pull-down attic stairway was not properly attached to the rough framing with 16d nails or 1/4" x 3" lag screws per manufacturer's recommendations. (4 each side 3 each end) This will void the manufacturer's warranty. This is a safety hazard.
D - There is an inadequate platform in front of water heater, HVAC system. This makes inspection, maintenance, and repair difficult and hazardous. A minimum of 30 inch of service platform is required along the entire front side of unit(s).

improper attachment of pull down stairs

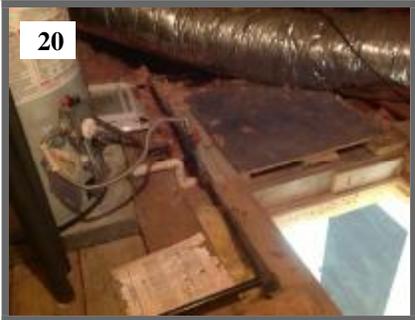
improper working platform in front of water heater

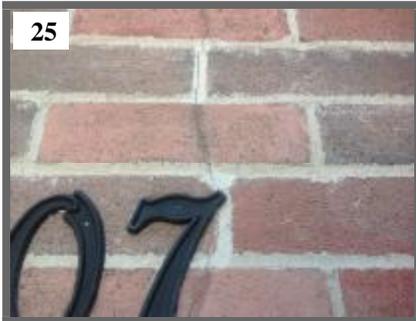
Crack in brick veneer located above garage

D - There were vertical cracks noted in the brick veneer. This type of crack is associated with lateral expansion and contraction due to extreme heat. Although this looks serious it does not indicate foundation movement. Recommend that a qualified contractor evaluate and repair as necessary.

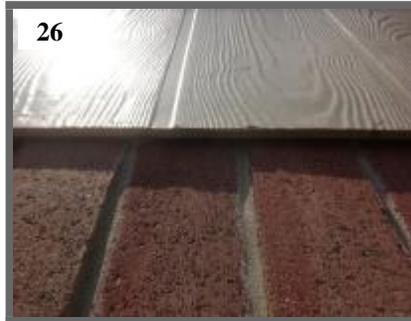
siding to brick needs caulking

D - Caulk and seal all gaps, cracks, and openings. There are various areas around the house that need sealing to prevent water and insect intrusion.

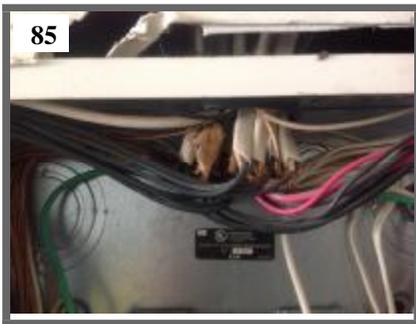
Conductor wires entering one knockout

D - Numerous branch circuit conductors are improperly entering the main electrical panel through a single large knockout located at the top of the panel box. Under current electrical standards, branch circuit conductors shall be evenly distributed and secured through the provided knockout holes. This does not comply with current fire regulations.

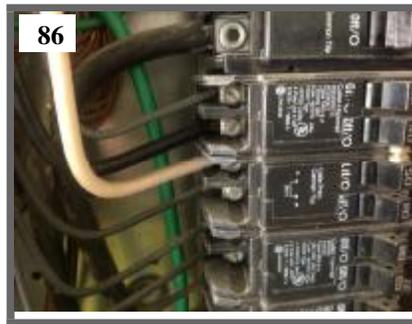
Neutral wire used as hot wire

D - Any white (neutral) wires used as hot wires should have black tape or coloring on them to indicate to service personnel that they are used as hot wires and not neutrals. Unidentified hot wires are a shock hazard.

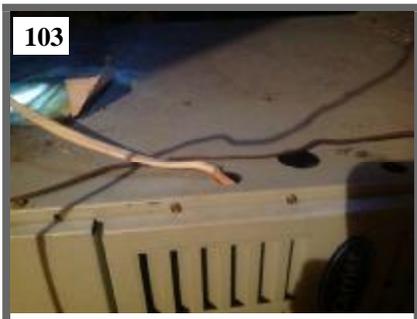
Unprotected wire going into furnace

D - The electrical wiring to the furnace is improperly attached. The wire entering the furnace should be protected to prevent damage to the wire. A damaged wire may cause an electrical shock.
